Research article

Understanding Effective Gully Control Measures in Imo State, Nigeria

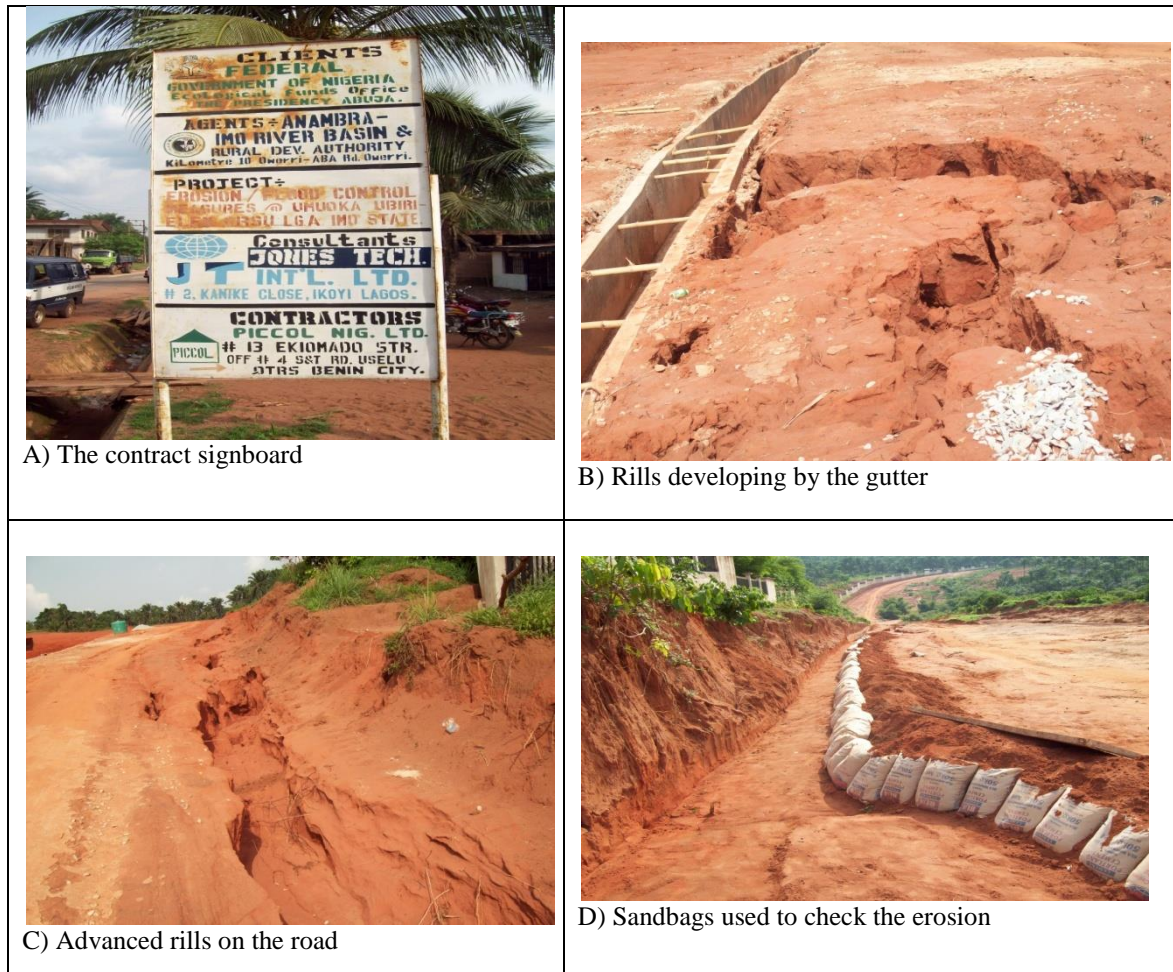
The control method adopted was simply flattening the gully by bulldozers down to the receiving water body (Azezie Asa River) a tributary of Orashi. The gully soil were poorly compacted, the concrete channel was also defective in design (e.g. the channel drainage length - 900m, depth - 1m, width-1m, thickness of concrete - 0.15m, no rip-rap, no groin, no armoury, no detention). This poor control measure has resulted in the formation of rills which have begun to develop measuring up to 700 m in length and 1.4 m in depth. Community efforts include the use of sandbags (Figure 3). The power of surface runoff was completely disregarded in this site. The situation is made worse by in-streaming activities downstream of the gully.

Figure 3: Umuoka Ubiri Elem erosion site

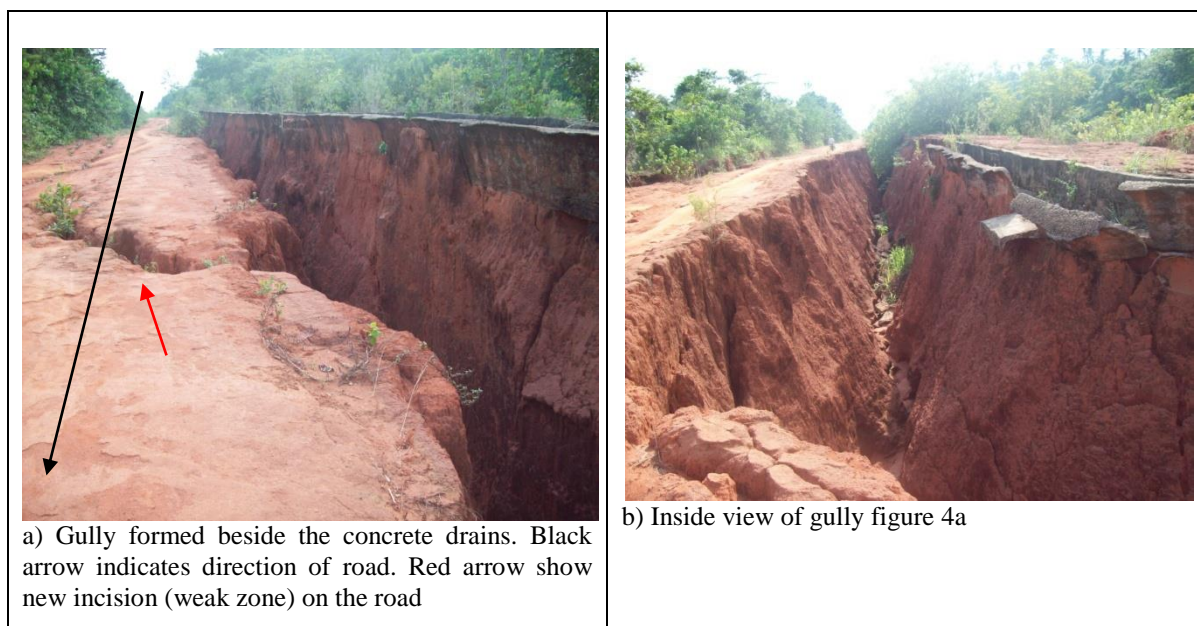
This gully developed from failed culvert. The length of the slope, and perhaps long duration and intensive rainfall initiated sheet erosion as a result of the loose soil in the area. As the sheet erosion occurs, the walls of the gutter (concrete drains) besides the earth became exposed and gradually collapsed, forming rill which later develop on weak zones to form three major gullies dissecting the entire slope into series of small rills forming a badland topography (Figure 4). Site investigation showed that at the design stage, the effective runoff for this watershed vis-à-vis the slope was not considered.

Figure 4: Ikeduru gully
